Fire Endurance of Mine Stoppings

By D. Ng, C. P. Lazzara, K. E. Mura, and C. Luster

Report of Investigations 9207

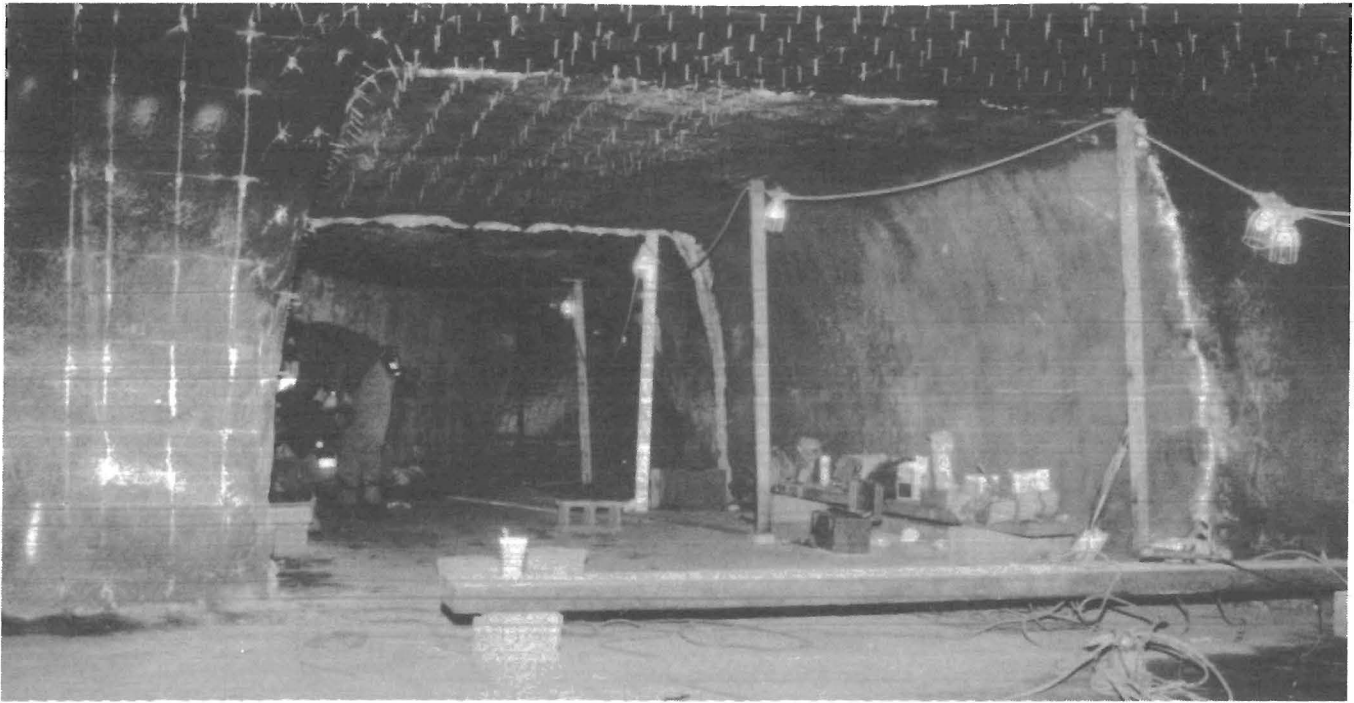
Figure 3.—Installation of fireproof material at test site.

and roof immediately in front of and behind the test stopping and in the crosscut were therefore protected with fireproof ceramic fiber blankets. The ceramic blankets were installed by impaling them on stainless steel studs that were cemented in holes drilled into the roof and ribs of the test area at spacings varying from 1.2 to 1.5 ft (fig. 3). Additionally, a layer of sand, about 2 in thick, was used to protect the concrete floor in front of the stopping from potential spalling because of the extreme heat.

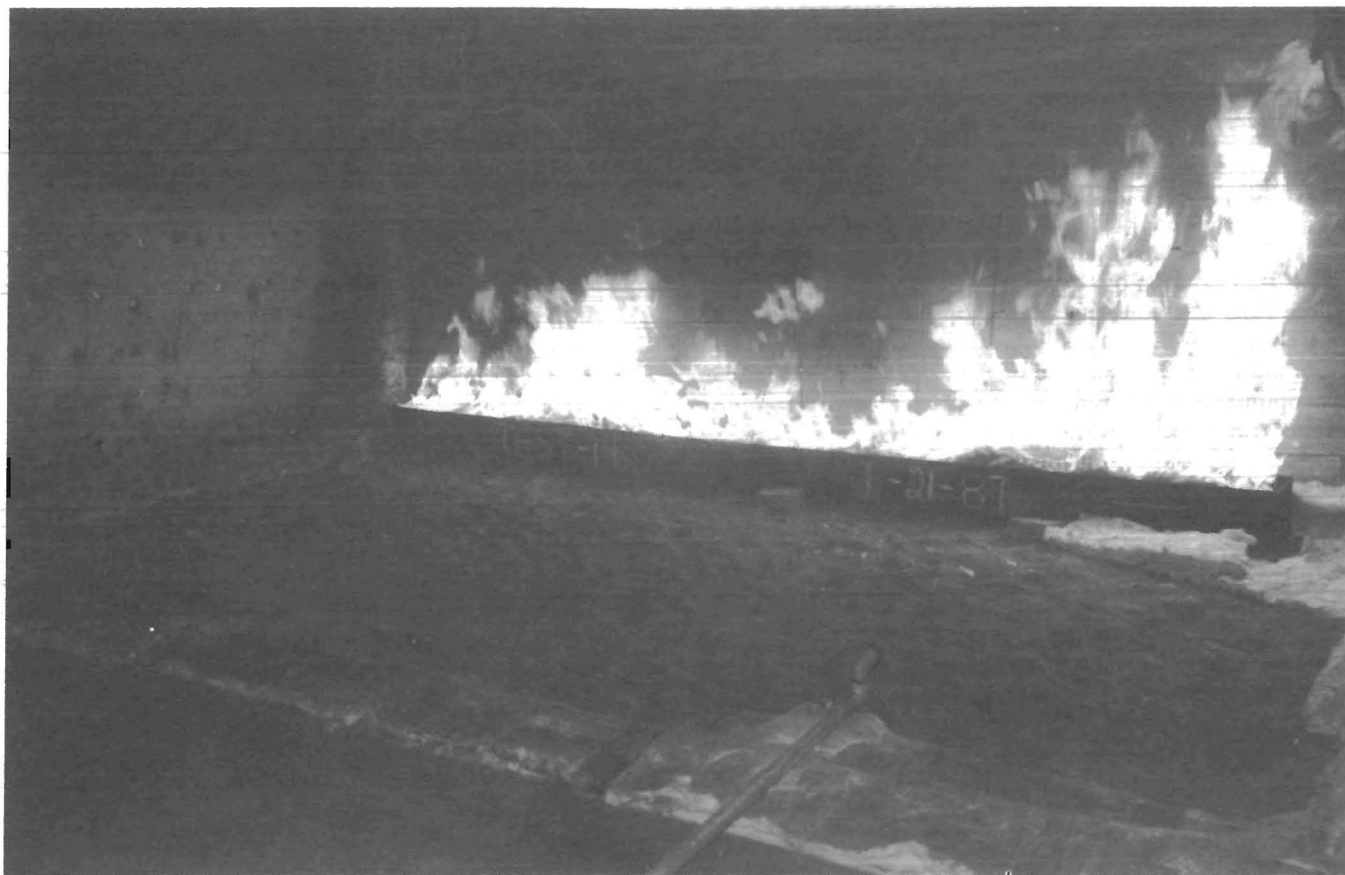
Figure 10—Tray fire.

A fuel delivery rate of 0.7 gal/min was found to produce the desired fire characteristics—a fire over the entire tray without excessive smoke (fig. 10). The heat output of the fire was about 75,000 Btu/min. It took about 10 min for the flames to spread over the surface of the tray and the fire to "burn in." A tray fire with these characteristics and a 70-min duration was selected as the standard fire for the stopping tests.
